ACCIDENT REPORT

HCLJ530-000074 Aircraft Accident			
Aircraft:	Ventus 2CXT	Registration no:	OY-XXB
Engine:	Solo 2350	Flight:	Private flight, VFR
Crew:	1 – minor injury	Passengers:	None
Location:	Gliding Centre Arnborg	Date and time:	05.04.2009 at 1521 UTC

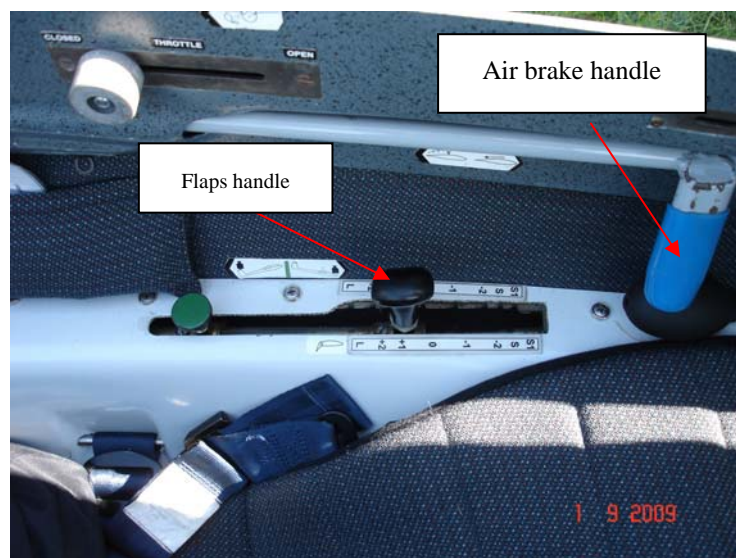
Fig. 1

The glider is manufactured in Germany, and is marketed under the name Ventus 2CXT. The glider is constructed especially for high-speed flight. To further improve flight performance profile at high speed, flaps had been designed not only for downward deflection, as is the case with traditional flaps (positive flaps), but were also able to deflect upward (negative flaps). The flaps were operated by means of the flaps handle, positioned on the left hand side of the cockpit. Directly in front of the flaps handle was the air brake handle (fig. 1).

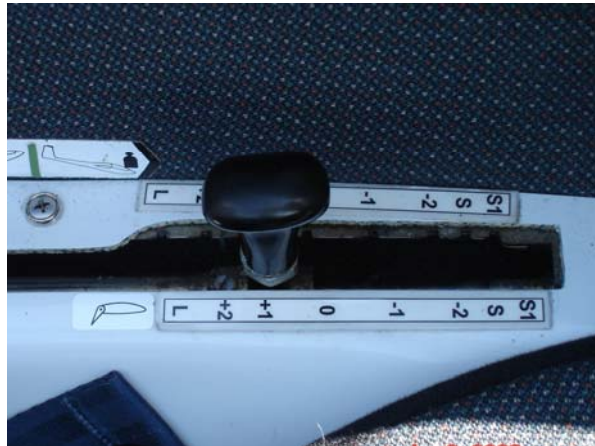
Fig. 2

The handle had to be moved from 0 towards L at decreased flight speed and towards S at increased flight speed (fig. 2). Figure 3 shows the handle in transit (unlocked) position.

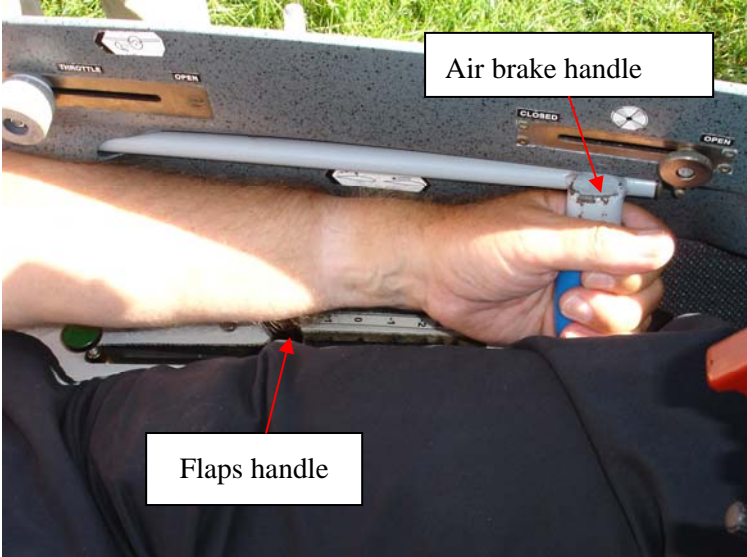
Fig. 4

When operating the air brake, the handle initially had to be pulled towards the pilot's knee to release the over-centre mechanism. When the over-centre mechanism was released it gave a jolt in the handle, which was normal (fig. 4).

Several pilots, who had previously operated this type of aircraft, have informed the Accident Investigation Board that it felt natural, either consciously or unconsciously, to use the flaps handle as an armrest when using the air brake (fig. 4).

As illustrated in the photo, there is not much space between the flaps handle and the air brake handle. In several on-the-ground tests of the air brake handle, it was found that unintentional release of the flaps handle was possible, partly because of the pull of the air brake handle when released from the over-centre mechanism combined with the pilot resting his/her arm on the flaps handle.

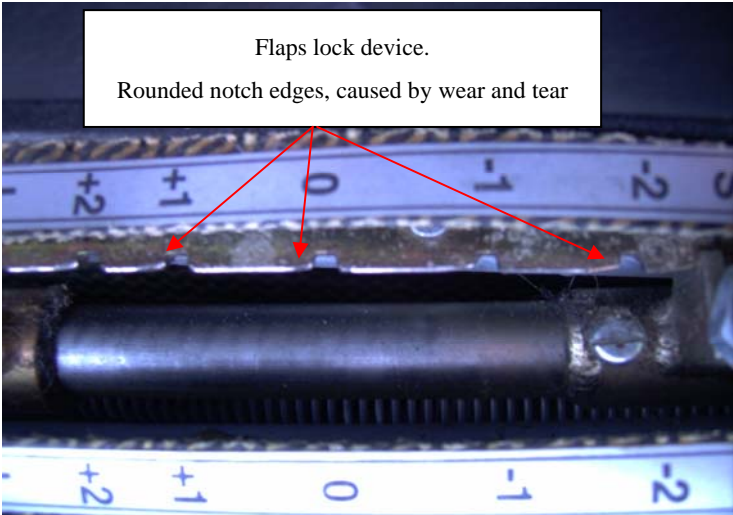
Fig. 5

The flaps handle casing, which allowed for adjusting the flaps into various positions, consisted of eight notches. As illustrated in fig. 5 below, these notches can be more or less worn, and consequently may not lock the handle into the correct position. In this particular aircraft the notches were worn. It consequently did not take much force for the handle to slide out of the locked position.

Based on the results of its investigation, the Accident Investigation Board concludes that the flaps handle was most likely released from its neutral position - due to a combination of poor tension and worn notches not locking the flaps handle correctly into place - when the pilot at 5-8 metres altitude chose to fully open the air brakes. The flaps handle slid all the way down into setting S1 because of the spring-load mechanism.

- the European Aviation Safety Agency (EASA) evaluates the design, and/or possibly introduces a maintenance scheme including wear and tear limitations for the flaps locking device as well as an adjustment procedure for the handle spring, so that unintentional changing of the flaps position is not possible.
