ACCIDENT REPORT

HCLJ530-000074 Aircraft Accident			
Aircraft:	Ventus 2CXT	Registration no:	OY-XXB
Engine:	Solo 2350	Flight:	Private flight, VFR
Crew:	1 – minor injury	Passengers:	None
Location:	Gliding Centre Arnborg	Date and time:	05.04.2009 at 1521 UTC

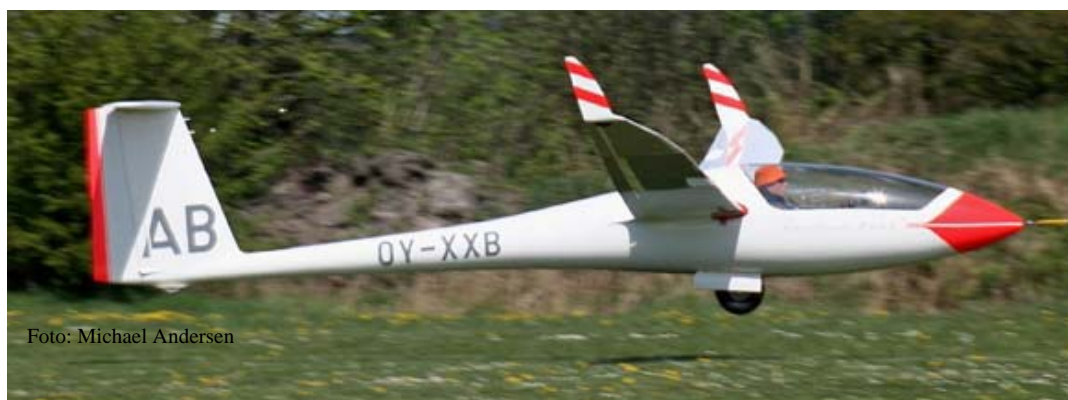
Upon crossing the beginning of runway 27 at 10-15 metres altitude, the air brake was fully opened. Shortly after – at 5-8 metres altitude – the pilot heard loud rattling noises, followed by a loud bang. The glider decelerated drastically as it hit the runway 27 without the pilot regaining control. The glider was substantially damaged.
